Manhole Inspection Summary

Manhole # S31KK_025MH

Location Address: **1531 NORTH AVE**

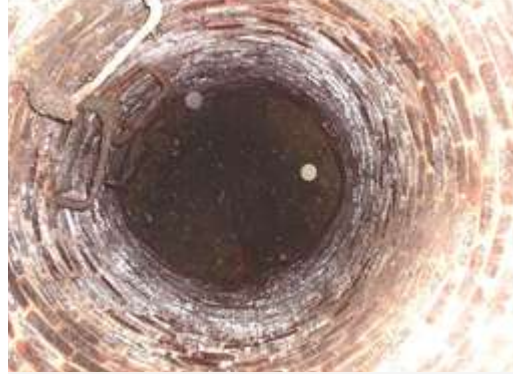
Top View

Corroded steps. Bench and Channel debris.

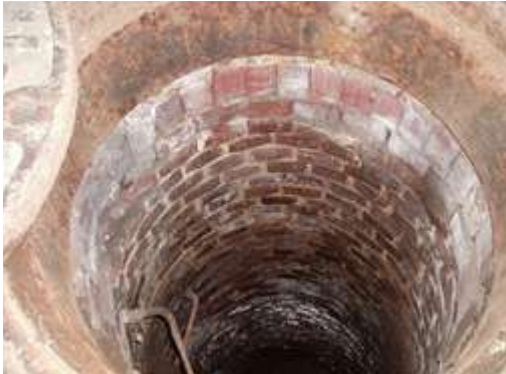
Defect

Frame leaks. Adjustment deterioration and infiltration. Barrel infiltration - other side.

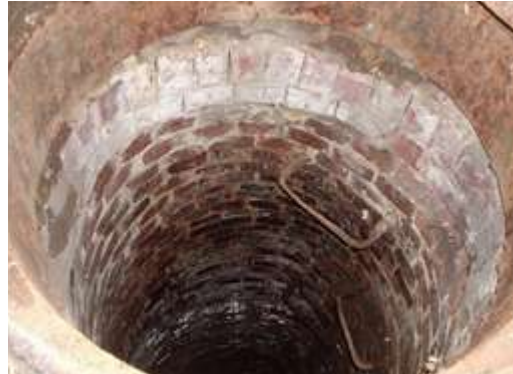
Defect

Frame leaks. Adjustment deterioration and infiltration. Barrel infiltration.

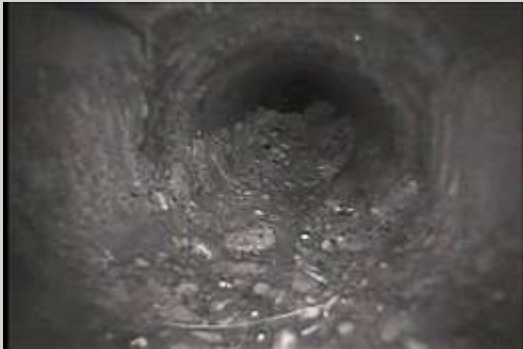
8 in. Circular Gravity Sewer Pipe Out @ 12 O'Clock

Deposits: ☐ None ☒ **Mud** ☐ Sludge ☒ **Debris** ☐ Grease

Silt Depth: **4** (in.) Deposits Extent: **Medium**

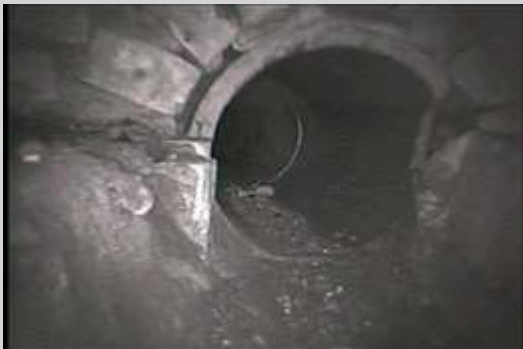
8 in. Circular Gravity Sewer Pipe In @ 5 O'Clock

Deposits: ☐ None ☒ **Mud** ☐ Sludge ☒ **Debris** ☐ Grease

Silt Depth: **0** (in.) Deposits Extent: **Light**

Infiltration: **Evidence** Pipe Seal Cond: **Broken**
